**RIVER BANK EROSION AND BOAT
WAKES ALONG THE LOWER SHUSWAP
RIVER, BRITISH COLUMBIA**

FINAL PROJECT REPORT

August, 2013

*Larissa Laderoute & Bernard Bauer
University of British Columbia Okanagan*

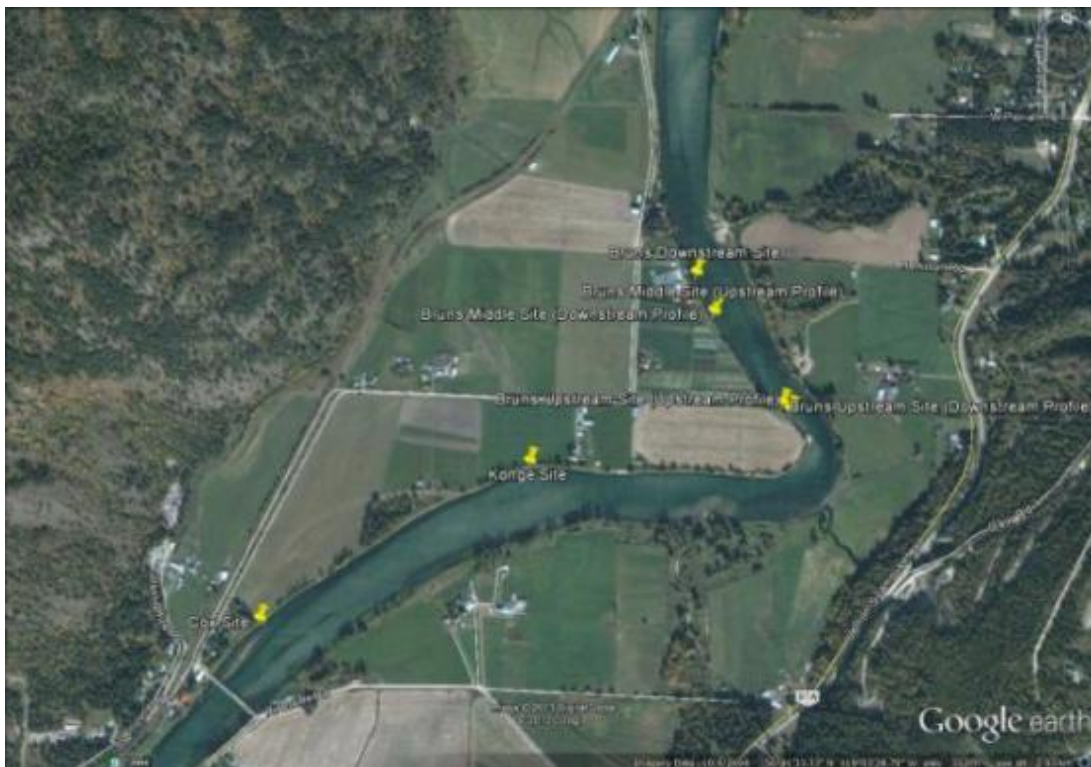
Figure 3.1 (a) Location of all seven erosion-pin sites along the Lower Shuswap River upstream of the mouth as it enters Mara Lake (upper photo); (b) Close-up of five downstream sites below the Mara bridge crossing (lower photo).

A network of erosion-pin sites was established along the lower reaches of the river from just upstream of the town of Grindrod and extending to just upstream of the river mouth as it enters Mara Lake (Figures 3.1a and 3.1b). The sites were selected in consultation with local stakeholders who are familiar with the area and have worked on prior inventories of sensitive habitat. All pin profile lines were installed in early May at the start of spring freshet (May 2 for the Bruns sites and May 10 for the Cox, Konge, De Ruiters, and Stewart sites). Each profile line consists of 5-6 pieces of re-bar (60 cm length) inserted into the bank with a sledge hammer either vertically or horizontally depending on the bank topography. Often vertical (V) and horizontal (H) pins were installed in pairs in approximately the same location (i.e., at the base of a cut bank). For the purposes of this report, we do not differentiate between rates of horizontal and vertical erosion. However, it should be kept in mind that, all other things being equal, the rate of bank retreat in the horizontal is typically more rapid than in the vertical. This generalization does not apply to situations where there is significant bank slumping or in zones of cyclic sedimentation depending on river stage (i.e., eddy recirculation zones). The methodology involves installing the re-bar flush with the ground surface initially and then returning to the site periodically to measure the amount of erosion (or deposition) that has taken place in the intervening period. A metal detector is used to find the pins, and for this study, pin recovery was excellent after the spring freshet subsided and personnel were able to access the bank safely.

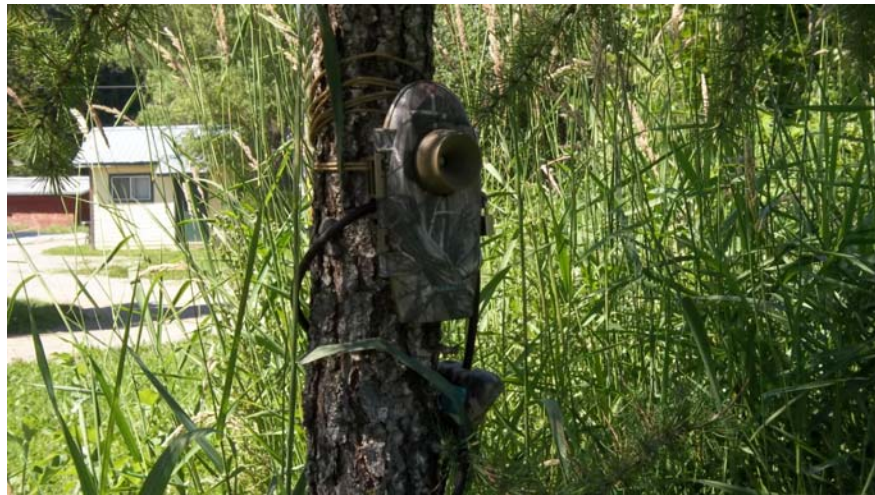
Figure 3.9 Stand-alone camera system used for boat traffic monitoring.

Despite the common assertion (in many places across the world) that boats cause significant shoreline erosion, there are surprisingly few data sets on boat traffic intensity. Without such data on how many boats actually use the waterway, as well as information on the type of vessel and speed, it is impossible to assess what the relative contribution of boat wakes is to the erosion problem. For this study, two automatically triggered cameras (PlotWatcher™ Pro) were deployed beginning in mid-May, well before any significant boat traffic appeared on the river. One camera was installed on the Bruns property (Figure 3. 9), where boat traffic was expected to be quite intense. Another camera was installed on the De Ruiter property upstream of Grindrod. The cameras were programmed to capture an image every three seconds from 5 am until 10 pm, daily. The digital images were stored on an internal memory card that was replaced during routine maintenance visits. The memory cards had a 64 Gbyte capacity and they tended to fill up in about 10 days, so a weekly service schedule was adopted. Batteries required replacement every three to four weeks. The digital images were downloaded on to a PC, and proprietary software (GameFinder™) that came with the camera was used to watch the images in

a video-streaming mode and for editing. In addition to total boat count for each day, information on the time of passage, sailing direction, and type of watercraft (speedboat, pontoon, or PWC) was obtained from the images. Single still photos of every vessel were extracted for further analysis if needed. Boat traffic monitoring was continuous for the period May 19 through August 24, which facilitates an assessment of the variability in boat traffic according to weather, day of the week, and river stage.

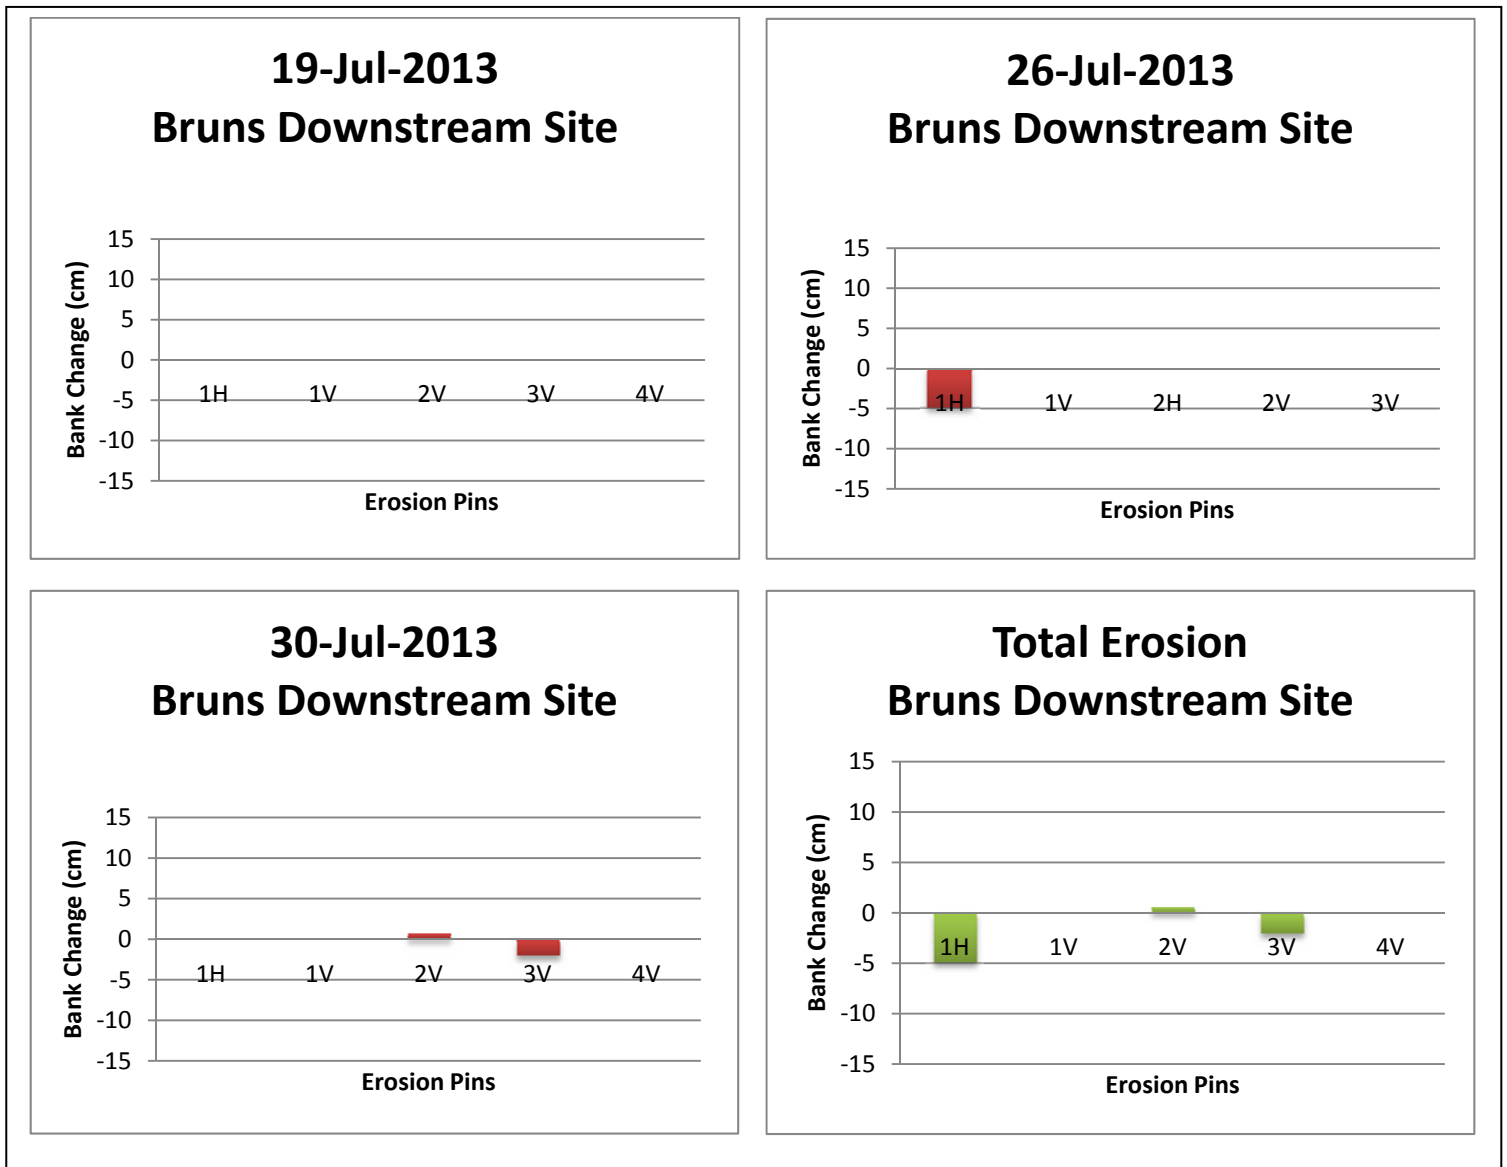
Figure 4.2 Bank changes at the Bruns Downstream Site.

Table 4.1 Bank change at the Bruns Downstream site. Negative numbers indicate erosion; positive numbers indicate accretion; NF indicates that the pins could not be found or were submerged and not accessible.

The pins installed at Bruns site (Downstream Profile) showed minimal bank change throughout the measurement period (Figure 4.2; Table 4.1). On July 19, the pins could not be located so there are no measurements. On July 26, only the upper pins were exposed and measured whereas the pins on the lower part of the profile were submerged and could not be accessed safely. However, 5 cm of erosion was measured at the highest pin (1H) perhaps in response to flood erosion and bank de-watering. As the boating season commenced, slight erosion was observed at the pin closest to the water line (3V).

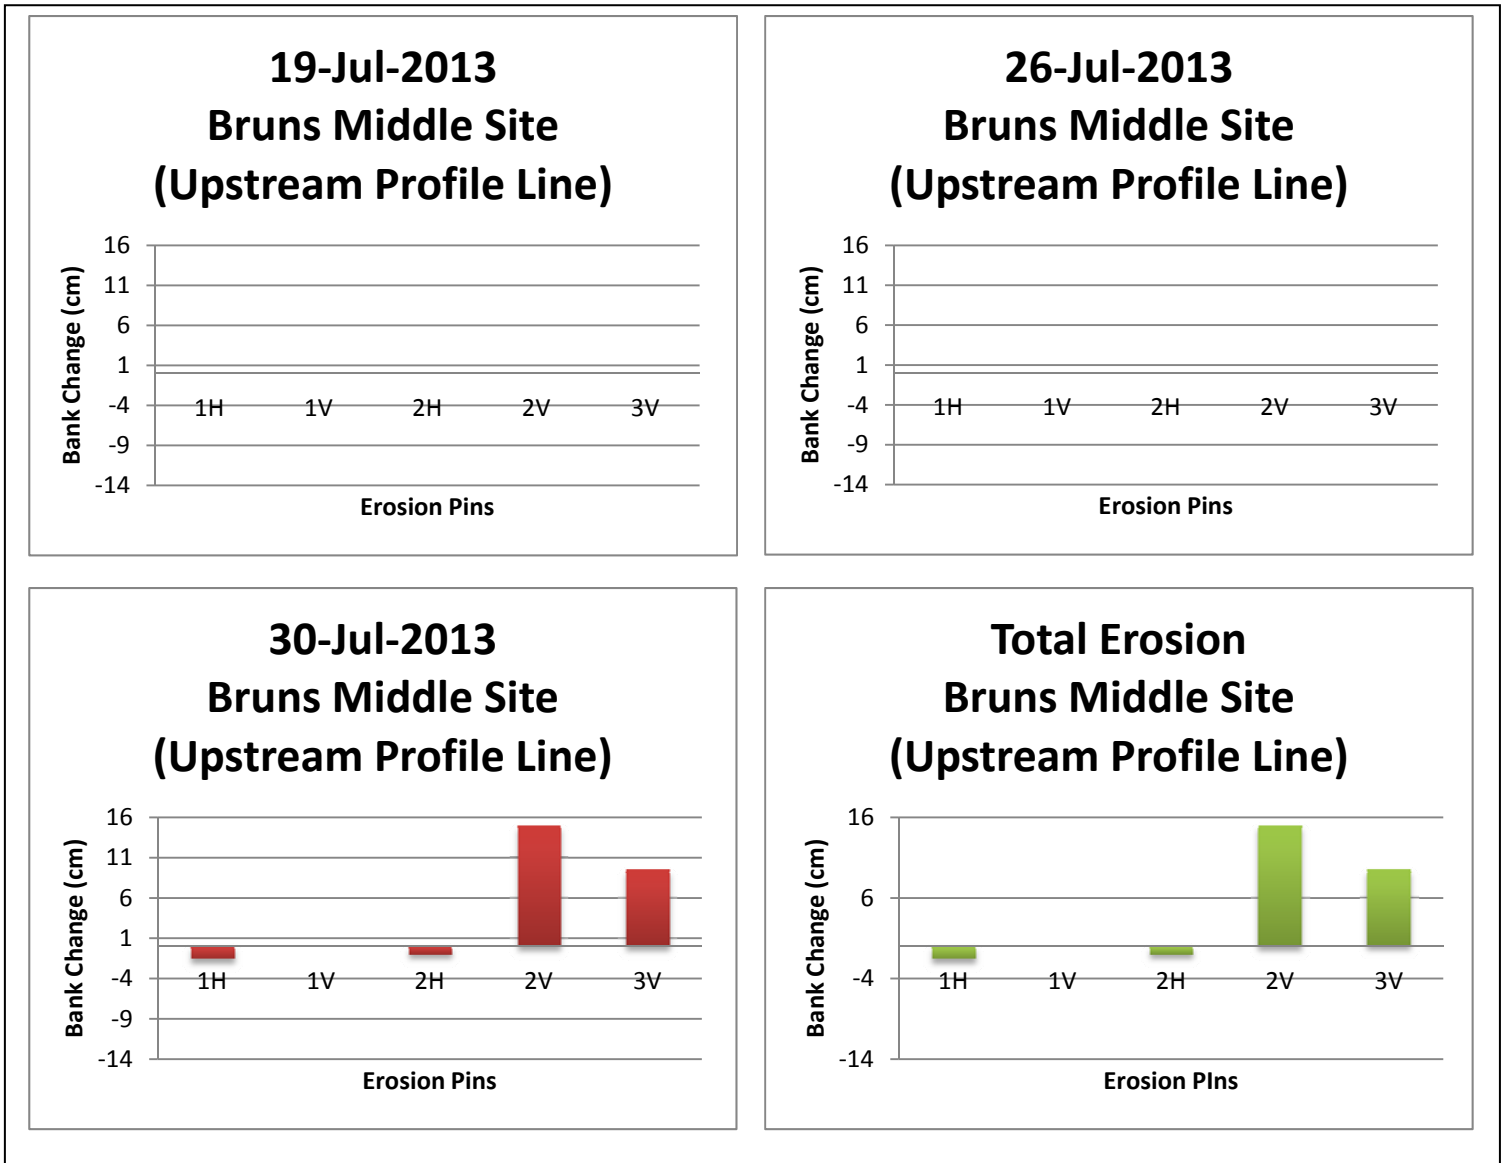
Figure 4.4 Bank change at the Bruns Middle Site (Upstream Profile Line).

Table 4.3 Bank change at the Bruns Middle Site (Upstream Profile Line). Negative numbers indicate erosion; positive numbers indicate accretion; NF indicates that the pins could not be found or were submerged and not accessible.

At the Bruns Middle Site, both the Downstream Profile Line (Figure 4.3; Table 4.2) and the Upstream Profile Line (Figure 4.4; Table 4.3) experienced the same pattern of bank change. There were no pin measurements on July 19 and July 26 due to high water and poor pin recovery. On July 30, the measurements indicate slight erosion on the upper parts of the profile and significant deposition on the lowermost part of the profile (pins 2V and 3V), which corresponds to the gently sloping apron beneath the lower cut-bank. As will be noted later in the report, these silty-sandy deposits emplaced on the declining limb of the annual hydrograph are very susceptible to erosion by boat wakes, and they are essentially removed during the boating season (see Figures 4.36 and 4.37).

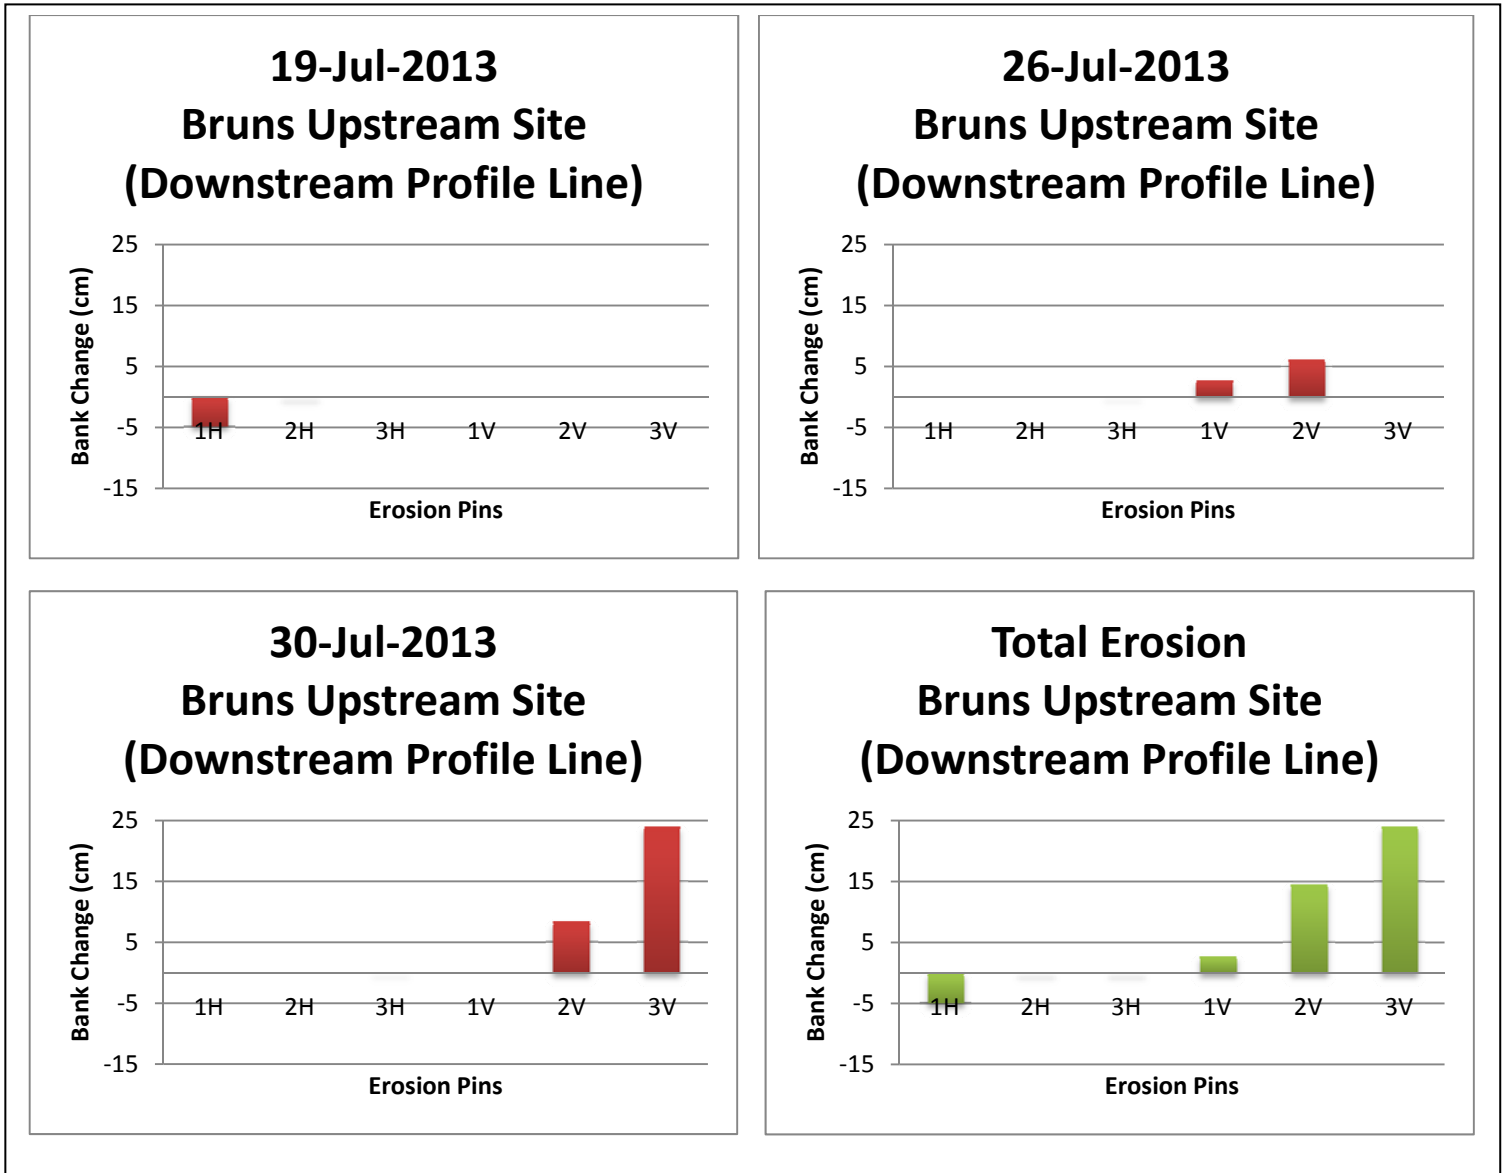
Figure 4.5 Bank change at the Bruns Upstream Site (Downstream Profile Line).

Table 4.4 Bank change at the Bruns Upstream Site (Downstream Profile Line). Negative numbers indicate erosion; positive numbers indicate accretion; NF indicates that the pins could not be found or were submerged and not accessible.

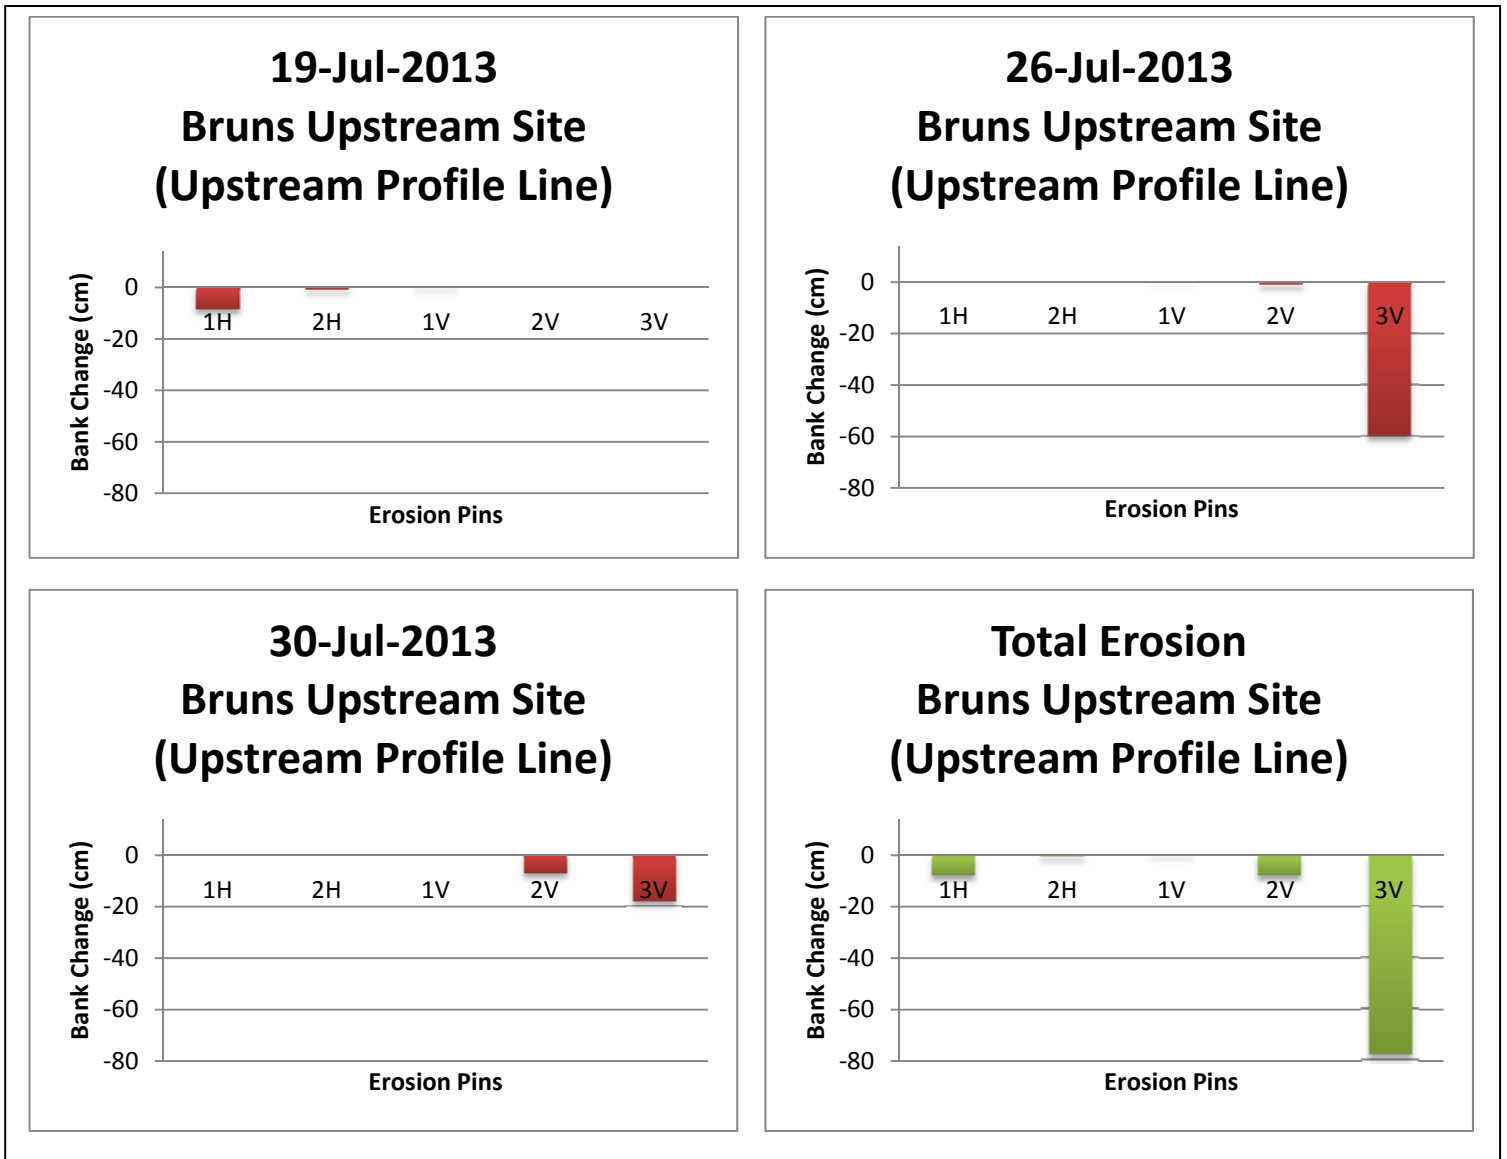
Figure 4.6 Bank change at the Bruns Upstream Site (Upstream Profile Line).

Table 4.5 Bank change at the Bruns Upstream Site (Upstream Profile Line). Negative numbers indicate erosion; positive numbers indicate accretion; NF indicates that the pins could not be found or were submerged and not accessible.

The Upstream Profile Line at the Bruns Upstream Site (Figure 4.6; Table 4.5) similarly experienced erosion along the upper part of the profile during the spring freshet. However, in contrast to the paired Downstream Profile Line at this site, the lowermost portion of the profile line experienced erosion rather than accretion. Again, the circumstances are somewhat peculiar because this site is fronted by a large eddy recirculation zone that occupies the lee of the large meander bend just upstream. As a consequence, it appears to be subject to significant deposition of sand and silt during flood flows. This high-stage deposit rapidly erodes at lower stage as the eddy recirculation current re-occupies a near-bank channel that cuts away toward the bank. Note that the July 26 measurement in excess of 60 cm shows that the pin found sitting on the bottom due to lateral erosion of the sandy apron toward the bank. Thus, the bank changes measured at the lower pins in this profile line, as well as those at the downstream profile line, are not characteristic of what one might expect at other sites along straight reaches. It is not believed that these bank change patterns are due in any way to boat-generated waves.

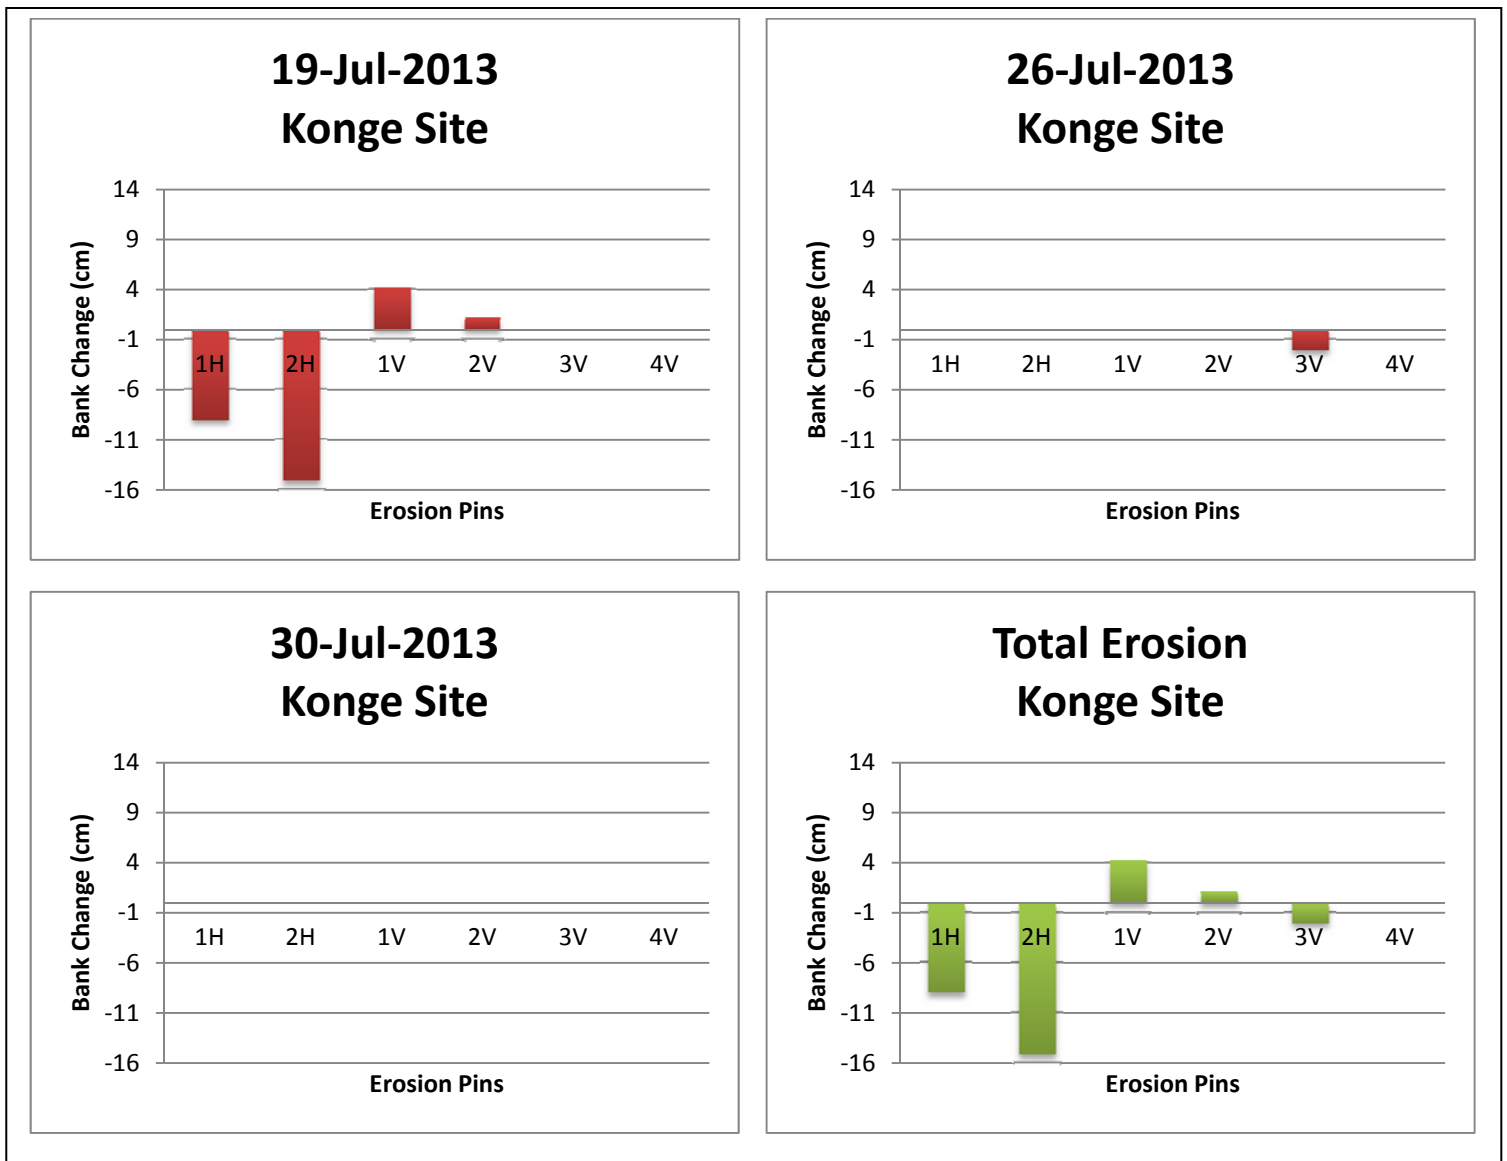
Figure 4.7 Bank change at the Konge Site.

Table 4.6 Bank change at the Konge Site. Negative numbers indicate erosion; positive numbers indicate accretion; NF indicates that the pins could not be found or were submerged and not accessible.

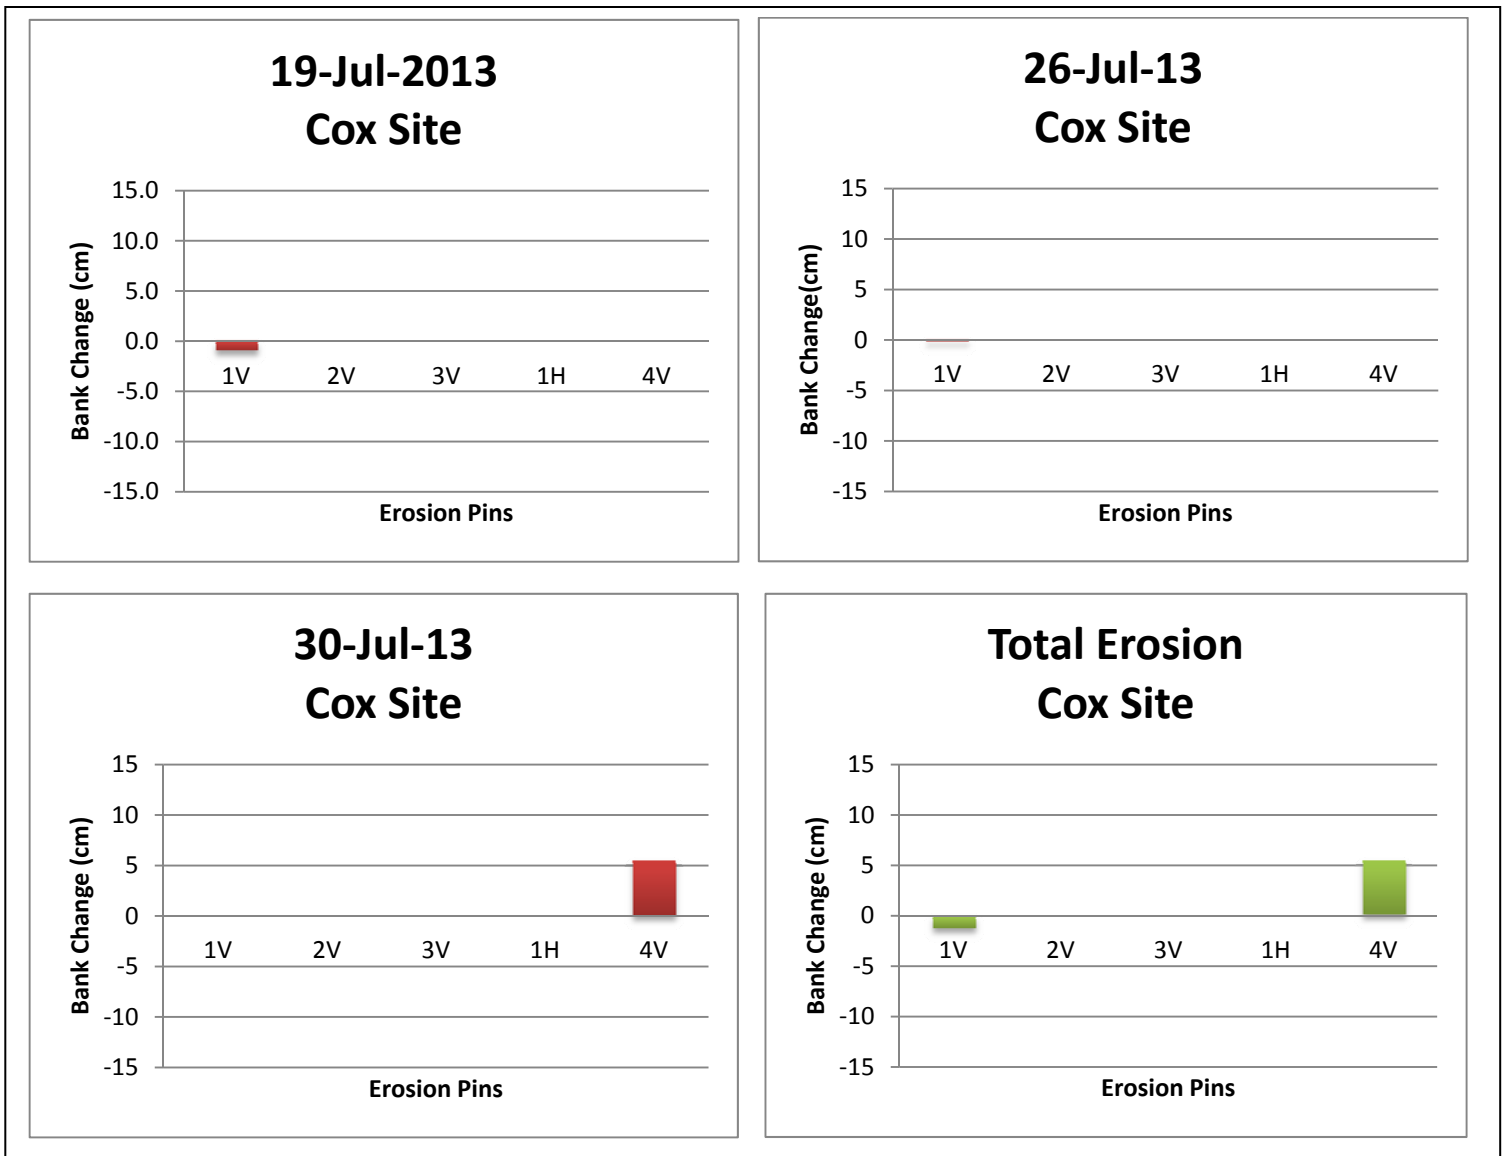
Figure 4.8 Bank change at the Cox Site.

Table 4.7 Bank change at the Cox Site. Negative numbers indicate erosion; positive numbers indicate accretion; NF indicates that the pins could not be found or were submerged and not accessible.

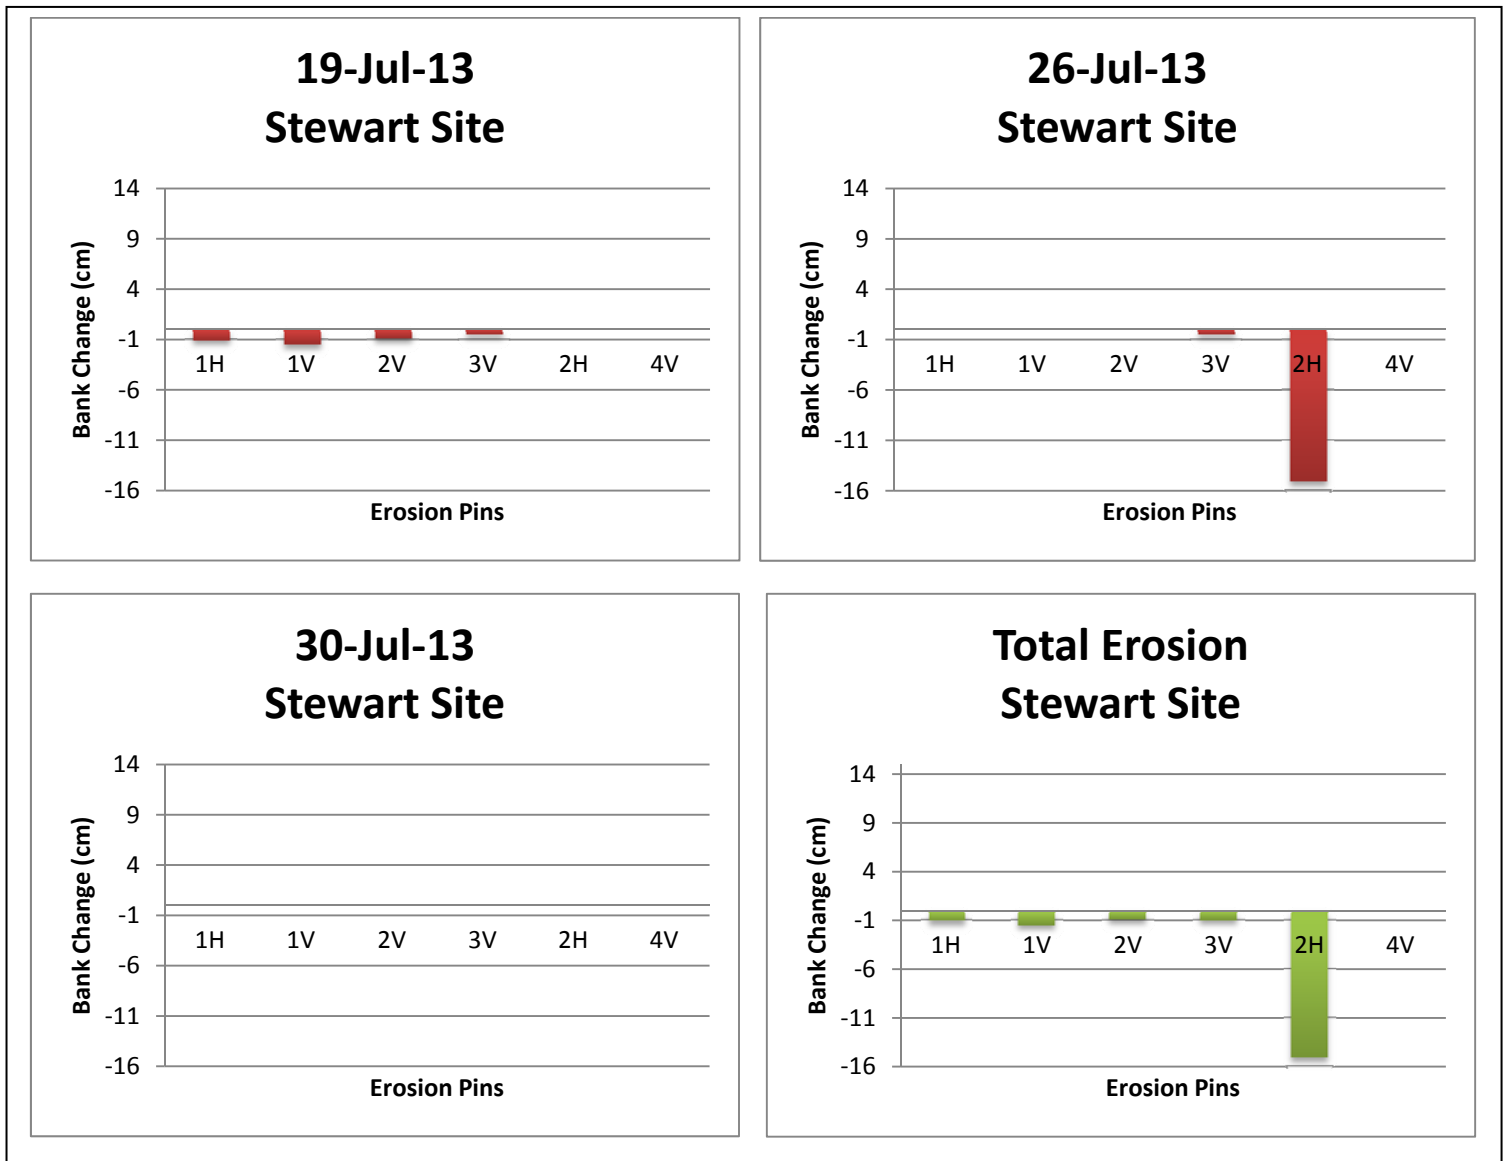
Figure 4.9 Bank change at the Stewart site.

Table 4.8 Bank change at the Stewart Site. Negative numbers indicate erosion; positive numbers indicate accretion; NF indicates that the pins could not be found or were submerged and not accessible.

At the Stewart Site (Figure 4.9; Table 4.8), the story is similar in that minor erosion was observed at the upper pins during the spring freshet. In addition, there was erosion at the lower cut bank (pin 2H) between July 19 and 26, which is likely due to bank weakness and sloughing of material as water level declines. Agitation by a few boat passages early in the season may also have contributed to bank erosion on the lower part of the profile.

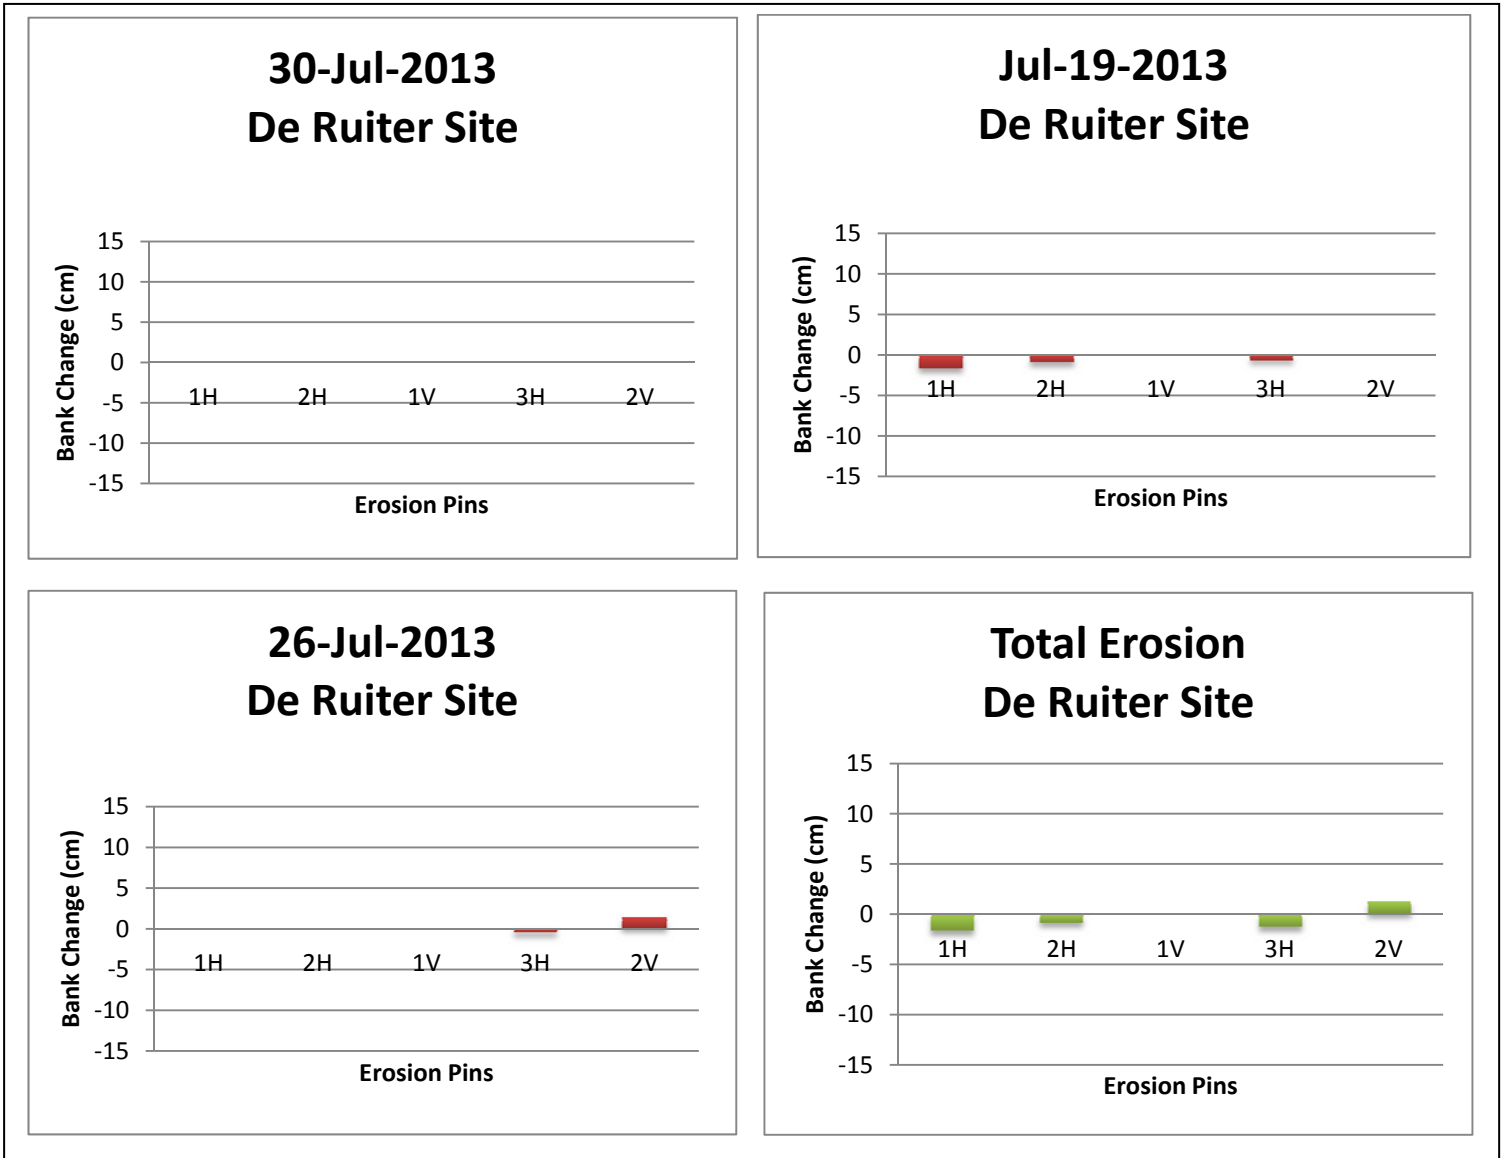
Figure 4.10 Bank change at the De Ruiter site.

Table 4.9 Bank change at the De Ruiter Site. Negative numbers indicate erosion; positive numbers indicate accretion; NF indicates that the pins could not be found or were submerged and not accessible.

The De Ruiter site (Figure 4.10; Table 4.9) experienced minor erosion during the spring freshet. The erosion that occurred here was mainly attributable to natural causes because there was minimal boat traffic above Grinrod (see Table 4.11). After the spring freshet, there was virtually no change as many of the pins were above the water line.

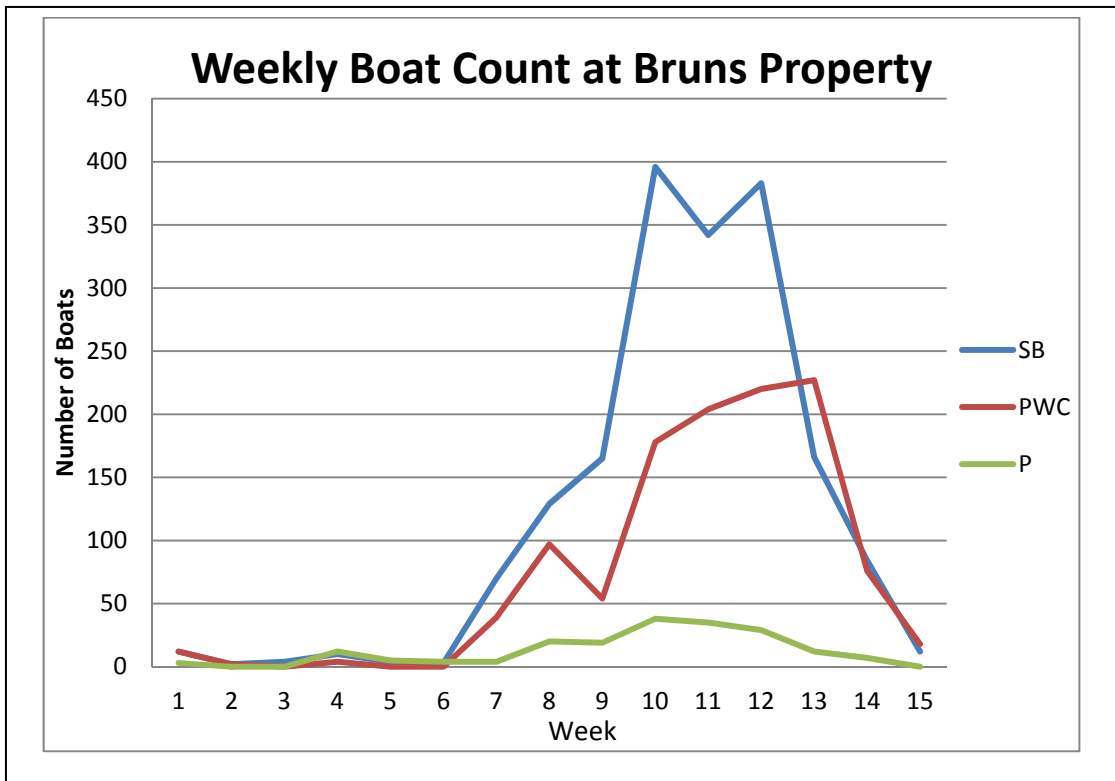
Figure 4.11 Weekly count of speedboats (SB), personal watercraft (PWC), and pontoon boats (P) at the Bruns property.

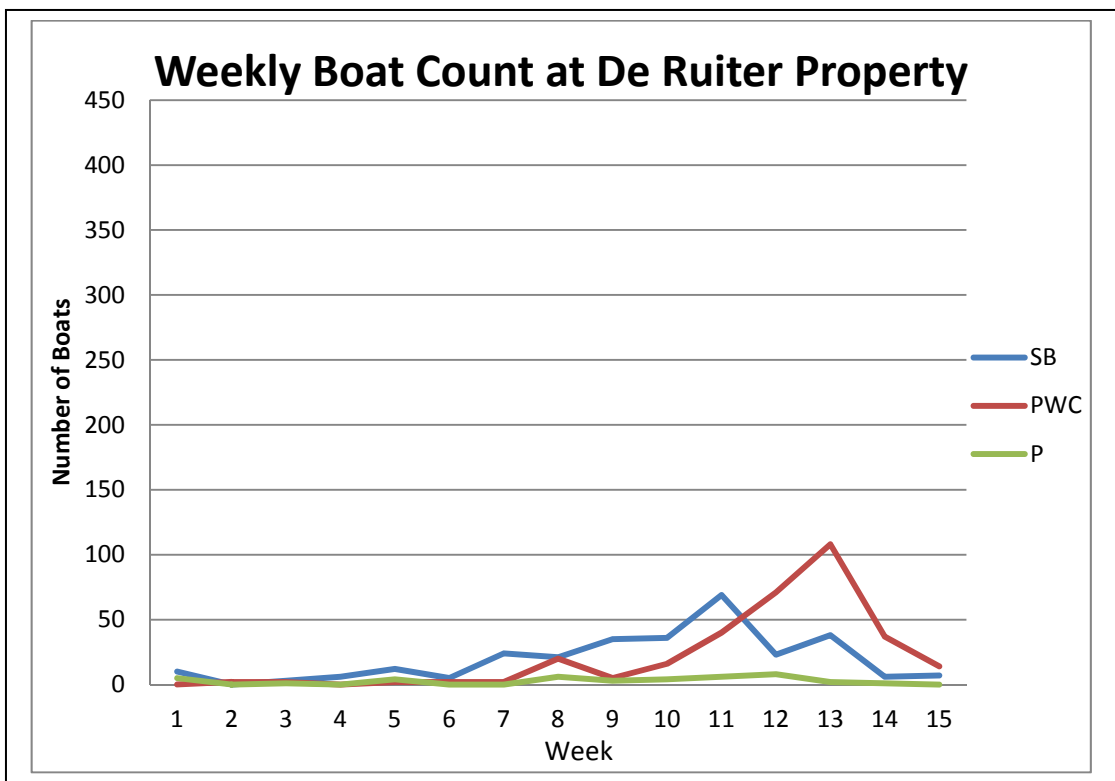
Figure 4.12 Weekly count of speedboats (SB), personal watercraft (PWC), and pontoon boats (P) at the De Ruiter property.

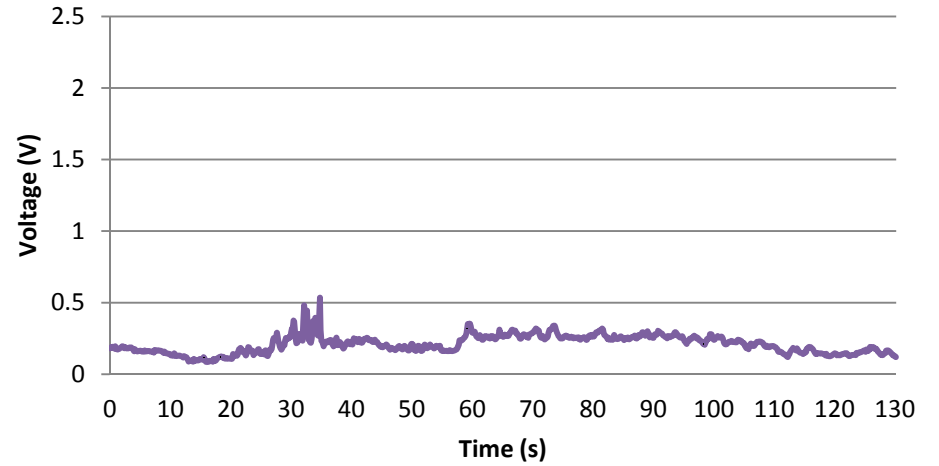
Turbidity Form From a Single Pontoon Passage

Figure 4.25 Turbidity levels generated from a wake of a single pontoon passage on the August long weekend.

A pontoon boat passage generates a maximum wave height of about 6-7 cm (Figure 4.24), which is of the same order as the speedboat, and similar turbidity levels (Figure 4.25). There appears to be a more immediate response to the primary waves in the wake packet with the pontoon boat, which may be explained by the slightly larger orbital velocities associated with the pontoon boat (Figure 4.26 and 4.17).

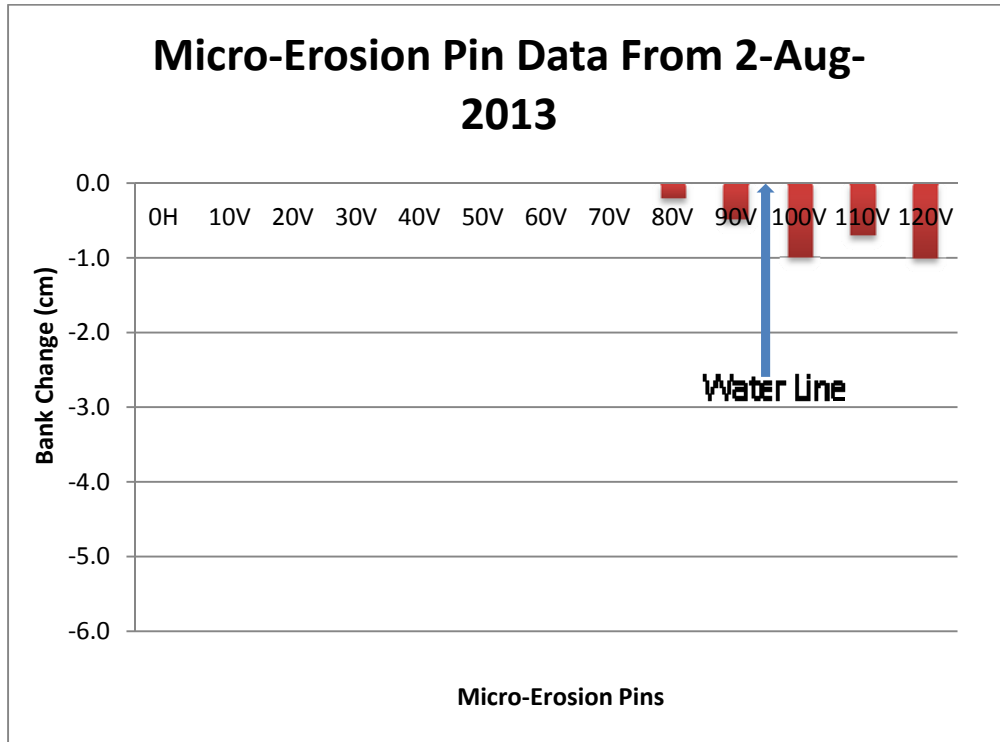
Figure 4.36 Micro-erosion pin data from August 2, 3013.

Table 4.14 Micro-erosion pin data from August 2, 2013.

Figure 4.36 and Table 4.14 provide data from the micro-erosion pins on August 2 whereas Figure 4.37 and Table 4.15 provide data on August 3. On both days, there was virtually no change in the upper parts of the profile. Although these upper pins were occasionally inundated by the larger boat wakes, they did not truly experience the same energy levels as pins lower in the profile that were consistently submerged in shallow water. The smaller erosion values measured on August 2 are, in part, explained by the fact that the profile was not installed until later in the day. The largest amount of erosion was measured on both days at the pins near the water line and just below the water line, and on August 3 this erosion amounted to about 5 cm over the course of the day. A conservative estimate of the number of vessels that passed by the site on August 2 is about 105, which yields an average erosion rate of about 0.5 mm per boat passage for the pins with the most erosion. These are rather extreme erosion rates, and it should be appreciated that they do not correspond to actual bank retreat. As noted earlier, this zone below the true cut-bank on the apron had a deposit of silt from the flood waters of the spring freshet, and now that the lower water stage provided direct access by waves, the fresh deposit was being eroded. Because these materials are weak and unconsolidated, they are easily eroded by any hydrodynamic disturbance. Tables 4.16 and 4.17 provide TorvaneTM assessments of the material strength, which shows clearly that these silty materials are much weaker than the clay bank materials higher up the profile.

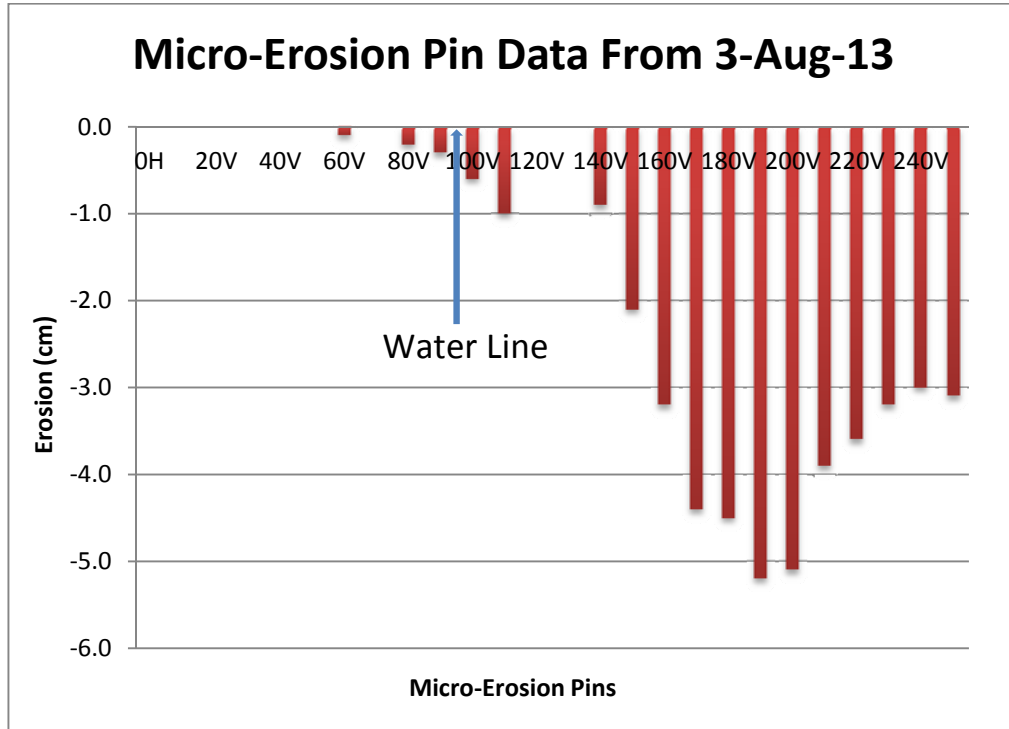
Table 4.15 Micro-erosion pin data from August 3, 2013.
